# 3D TRASAR™ Technology and swift action by the System Assurance Center prevent off-hours condenser leak

CASE STUDY - FOOD & BEVERAGE

CH-2052

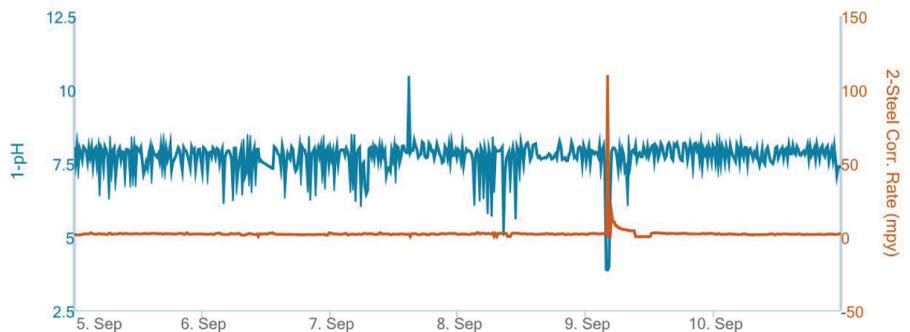
Figure 1 - 3D TRASAR Technology data from the event

The problem was discovered when a pH low alarm with a value of 3.90 was received by the SAC from the plant's 3D TRASAR controller.

See Figure 1 for the data points that triggered the alarm.

An SAC engineer quickly investigated and discovered that the pH had fallen to a highly corrosive level (below four) with corrosion rates spiking at the same time. If left undetected, a further drop in pH would have exposed the condenser to the corrosive environment even longer, resulting in additional corrosion.

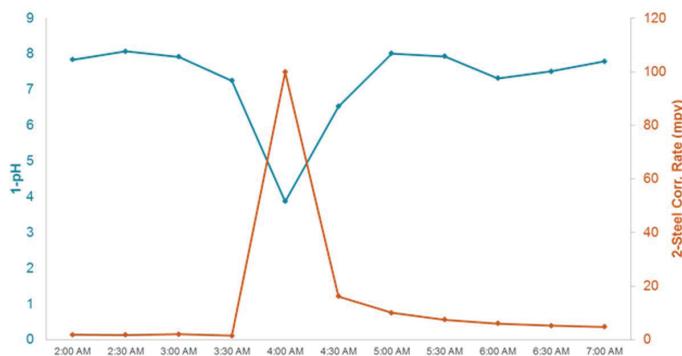
Figure 2 - Timeline of response to low pH alarm

Figure 2 illustrates how a quick response helped to bring pH and corrosion levels back to normal within minutes instead of hours or days.

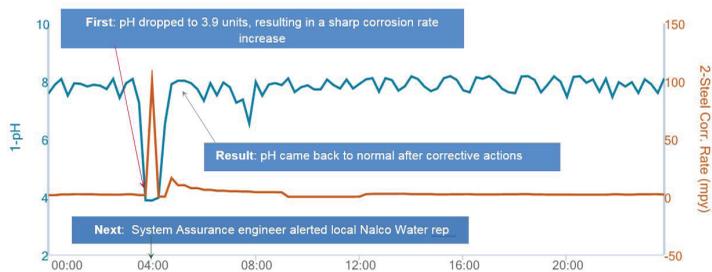
Figure 3 - Detailed data and corresponding timeline for the response

Figure 3 shows the detailed system data from the 3D TRASAR System and the response timeline.

After assessing the 3D TRASAR System data, the SAC engineer immediately called the Nalco Water sales engineer responsible for the plant. A detailed analysis was also emailed to him and was, in turn, forwarded to the customer. The sales engineer followed up with a phone call to the SAC, then contacted the plant's operations staff to check the onsite conditions. He found that due to some earlier interventions, all pumps had accidentally been left operating under manual conditions, including the sulfuric acid pump. He immediately put all pumps into automatic mode.

As a result of the 3D TRASAR Technology alert and the timely middle-of-the-night response by the SAC and the Nalco Water team, the plant was able to achieve the desired pH within 30 minutes of the initial alert. This rapid response saved the plant approximately US\$46,000 in condenser repairs and the associated maintenance costs and downtime.
