3D TRASAR™ Technology for Membranes and System Assurance Center play critical role in preventing membrane replacement at brewery

BACKGROUND

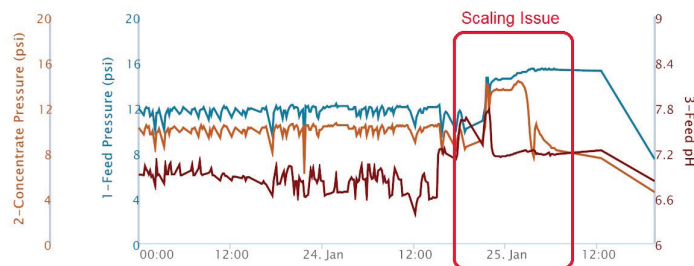
Figure 1 - 3D TRASAR System data from the event

The Nalco Water sales representative escalated the communication to the plant's operations staff, advising them to stop both Recovery RO units. After further investigation, the sales representative learned that the acid pumps had stopped a day earlier due to a power failure and the reject valves were in the closed position.

Figure 1 shows the detailed system data from the 3D TRASAR System and response timeline when the issue was spotted.

Recovery RO unit#2

Three months later, during the night, SAC began receiving alarms from the 3D TRASAR controllers on both Recovery RO units. After analyzing the 3D TRASAR System data, the SAC engineer troubleshooted the alarms and emailed the analysis to the sales representative. As this was a critical alarm, the

engineer immediately contacted the sales representative by phone to communicate the potential risk of missed acid dosage and severe scaling of the membranes.

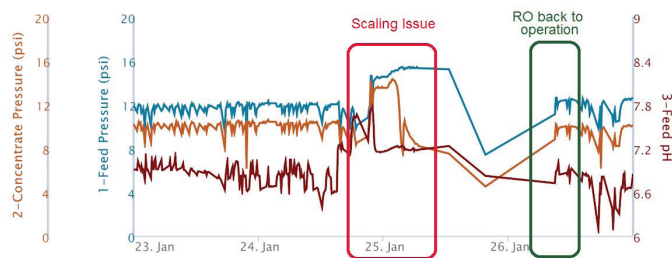
Figure 2 - Detailed data and the corresponding timeline for the response

Figure 2 shows the detailed system data from the 3D TRASAR System and the response timeline for resolution of the issue.

Recovery RO unit #2

Nalco Water's regional Industry Technical Consultant (ITC) advised the sales representative to perform a strong acid wash, which, when acted upon, prevented severe scaling of the membranes. The timely alarm, email notification and phone call from SAC empowered the sales representative to turn off the Recovery RO units before severe damage occurred. The customer was able to get both Recovery RO units back into operation with very little down time. To avoid future events, the customer installed an Interlock to shut down the RO units when feedwater exceeds 7 pH.
