# Condenser cleanliness program saves electric utility over \$1 million

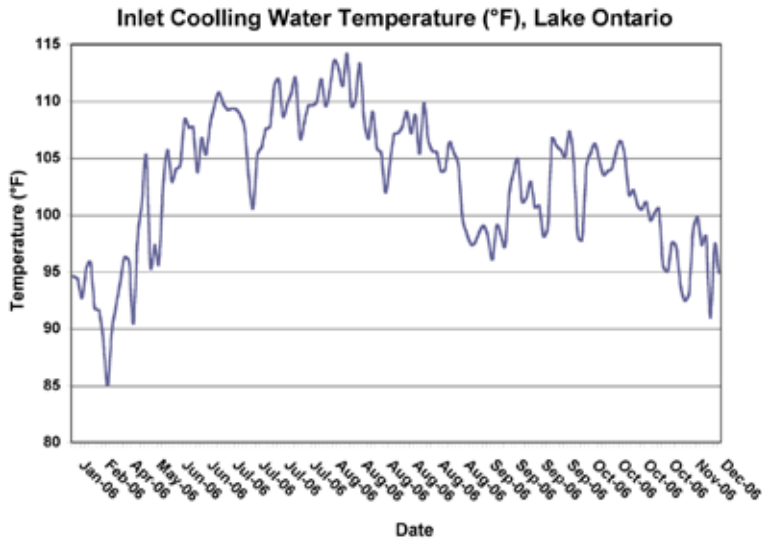
Figure 2 - Cooling Water Temperature varied throughout the year.

from Lake Ontario, which varies from about 35°F (2°C) to approximately 75°F (24°C) (Monthly Average Temperature), as shown in Figure 2.

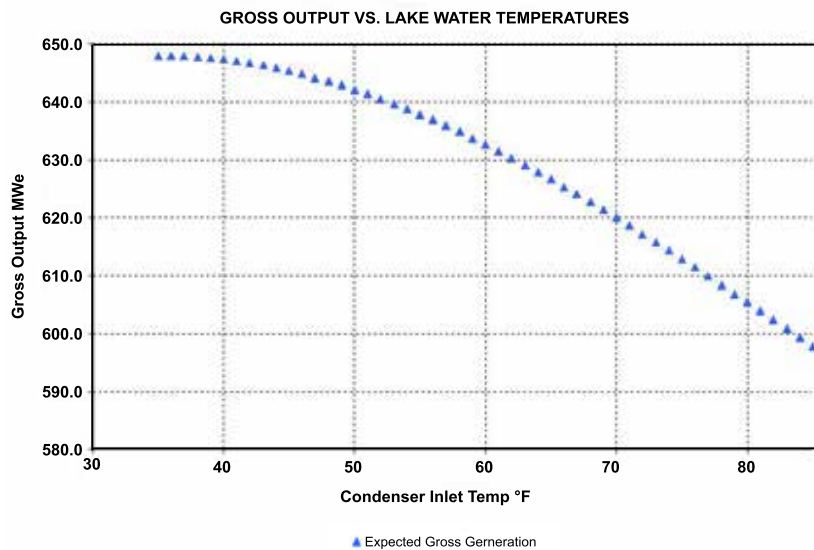
Figure 3 - Gross Output vs. Lake Temperature

In the cooler months, when lake temperatures are at their lowest, condenser fouling impact is low. As lake temperatures rise, the impact of existing fouling increases. Biological activity also increases during the summer months. As shown in Figure 3, the condenser fouling factor varies throughout the year, in response to changing temperatures.

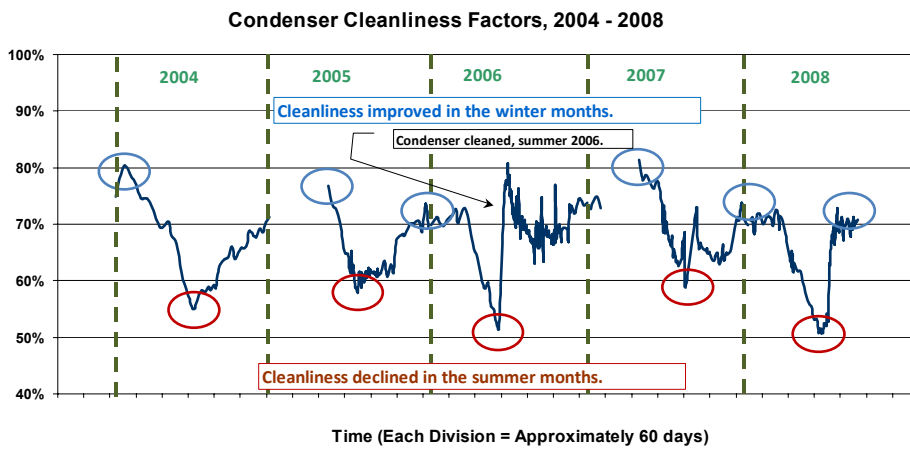
**Figure 4** - Condenser Cleanliness Factors varied with the seasons.

Figure 4 shows the output curves for the years prior to the de-silting of Unit 1's condenser. In the second week in June 2006, Unit 1's condenser was cleaned to avoid problems caused by excessive back pressures predicted for August. Following the cleaning, periodic chemical treatments were started. Their frequency increased over time. Cleaning, in conjunction with chemical injection, improved plant performance for the remainder of the cycle. This improvement in generation continued through the first half of the cycle started in 2007. In 2008, the cycle started to repeat and back pressure curves predicted that operations would again face challenges during high lake temperature months.

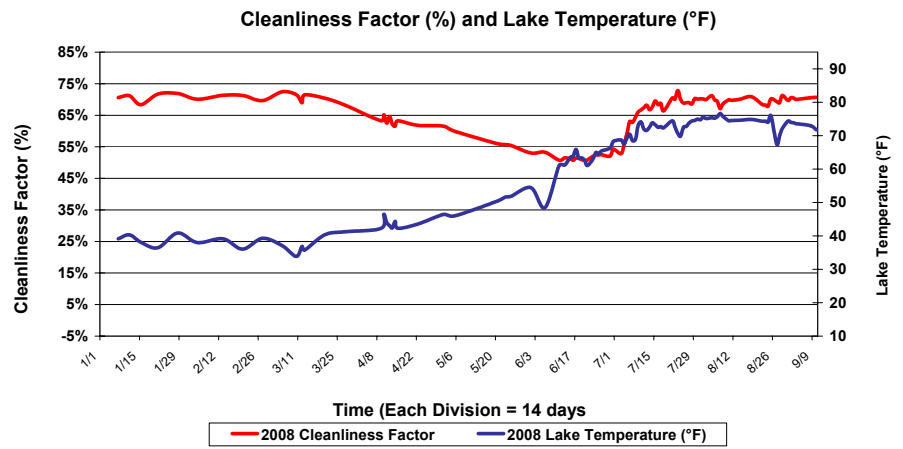
**Figure 5** - New program improved condenser performance, even under high stress, summer operating conditions.

The results were dramatic. Figure 5 tells the story. Lake temperatures increased in 2008 as expected and, also as expected, condenser cleanliness declined.

In June 2008, the new treatment program was initiated, but instead of condenser cleanliness continuing to decline as the lake temperature increased, cleanliness factors increased, clearly demonstrating the efficacy of the program.
