Ecolab® Heat Exchanger IQ™ Provides Unique Insight Into Cooling Water Treatment and Heat Exchanger Performance

CASE STUDY

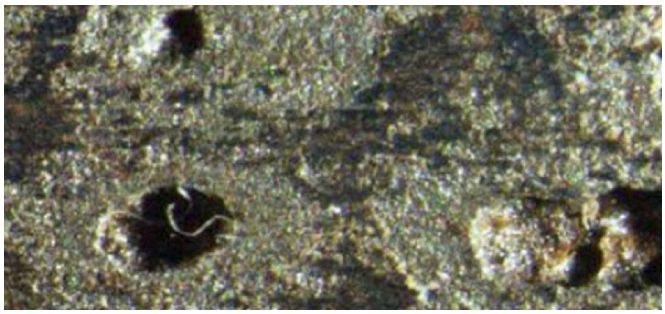
FIGURE 1

Photomicroscopy and deposit analysis conducted on both exchangers showed a buildup of mineral scale (Figure 1), primarily composed of iron phosphate, which resulted in under-deposit corrosion (Figure 2).

Exchanger 1: Velocity: 4.0-4.5 fps; Skin Temperature: 115°F

Sentinel provided a new understanding of the nature of the scale and performance under actual heat flux conditions. Correspondingly, the cooling water treatment program was adjusted, which included an overlay of pyrophosphate to sequester iron and minimize deposition. These changes were evaluated over the next exposure period, and Sentinel monitoring documented that iron phosphate scale had been eliminated and corrosion was also significantly reduced. Now considered as a best practice by the plant, they plan to continue to use Sentinel as a tool to optimize cooling water treatment and heat exchanger performance.
